# ***A Few Mine Related Considerations For An Enhancement Of SR 80, Near Bisbee Arizona***

***Nicholas M. Priznar***, *Engineering Geologist*, Arizona Department of Transportation

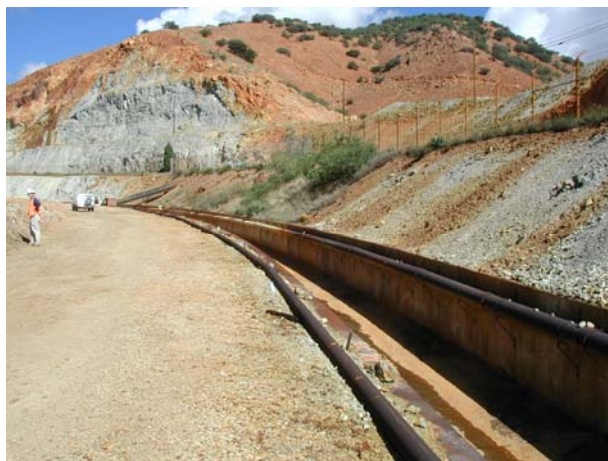
Red oxidized zone above and overlying (gray) hypogene alteration in the Sacramento Stock

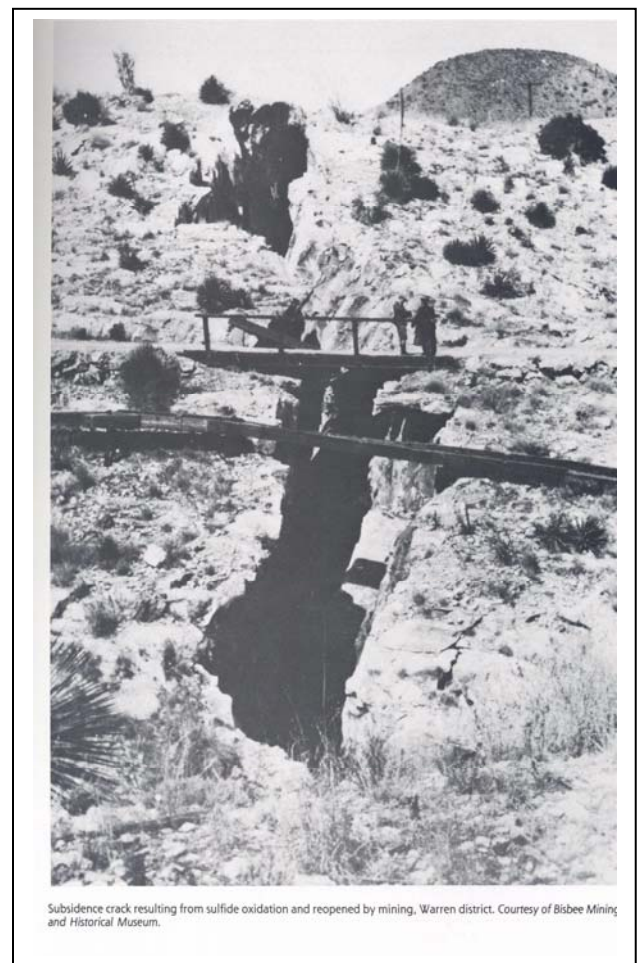
***Figure from: Cauty and Greely, 1987***

When originally reported by Carl Trischka in 1934, a display of crescent shaped open cracks and fissures curved up across the ridgeline of Queen Hill and extended to the southeast a length in excess of 1200 feet. Although no mention of the width of the fissure is given, historical photographs in the vicinity suggest they may have reached at least 10 feet in width. Mr. Edward Wisser (1927) in *Economic Geology* Vol. XXII, believed that a process referred to as “Oxidation Subsidence”, preweakened the Paleozoic sedimentary rocks by creating void space and initializing vertical and semi-horizontal (doming) discontinuities in the rocks in the time period before mining began. The mining of the deposits and the methods available at the time reactivated these incipient weaknesses and accelerated subsidence in the area.
